PHASE II

**FIRE RESISTANCE TESTING OF
BULKHEAD AND DECK PENETRATIONS**

**Final Report
December 1988**

| 1. Report No. CG-M-3-89 | | 2. Government Accession No. | | 3. Recipient's Catalog No. | |

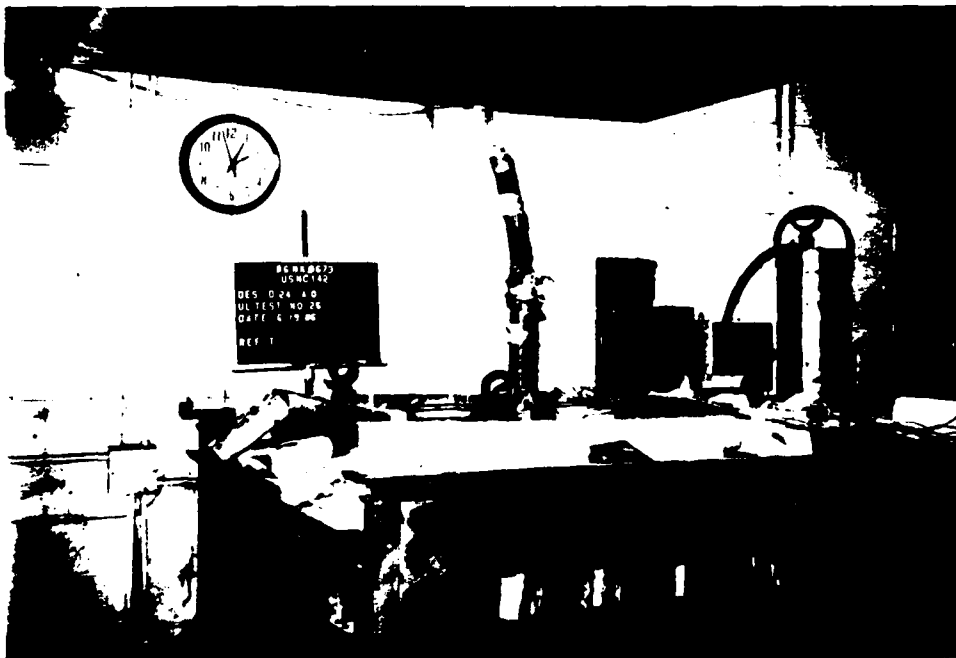
D24/A-O (Single Electrical Cable)

Eight penetrations (one copper penetration, one PVC penetration, three ventilation duct penetrations and three electrical cable penetrations) were tested for a Class A-0 rating. Two penetration samples, D22/A-0 and D24/A-0, failed the Class A-0 exposure tests (Figure 9). At eighteen minutes into the test the single electrical cable penetration D22/A-0 began to issue smoke at the interface of the cable and the brass terminal tube. At forty-two minutes the cable was still issuing

FIGURE 9. Class A-O Test Failures

smoke and was heavily charred. The cable jacket burst into flames at fifty-nine minutes. At the conclusion of the one hour fire test, a hose stream test was conducted. The single electrical cable penetration D24/A-0 began to issue smoke from the interface of the cable and the steel pipe at six minutes into the test. At forty minutes, the smoke intensity increased and the cable began to deteriorate badly. The hose stream test was conducted since the electrical cable did not collapse into the furnace.

Three single electrical cable penetrations (D22/A-0, D23/A-0, and D24/A-0) were tested for a Class A-0 rating. The brass terminal tube used in each of these penetrations was missing an o-ring fitting. Fire retardant oakum was substituted for the missing o-ring. Only sample D23/A-0 passed the Class A-0 test. Figure 13 shows that the three electrical cable penetrations had similar temperature readings at the 4-inch (10.2 cm) height above the steel plate but the penetrant which passed the Class A-0 test reached a temperature of 369°F (187.2°C) after 60 minutes at the 16-inch (40.6 cm) height, compared to temperatures of over 600°F (315.6°C) after 60 minutes at similar heights on the two penetrants which failed the Class A-0 test.

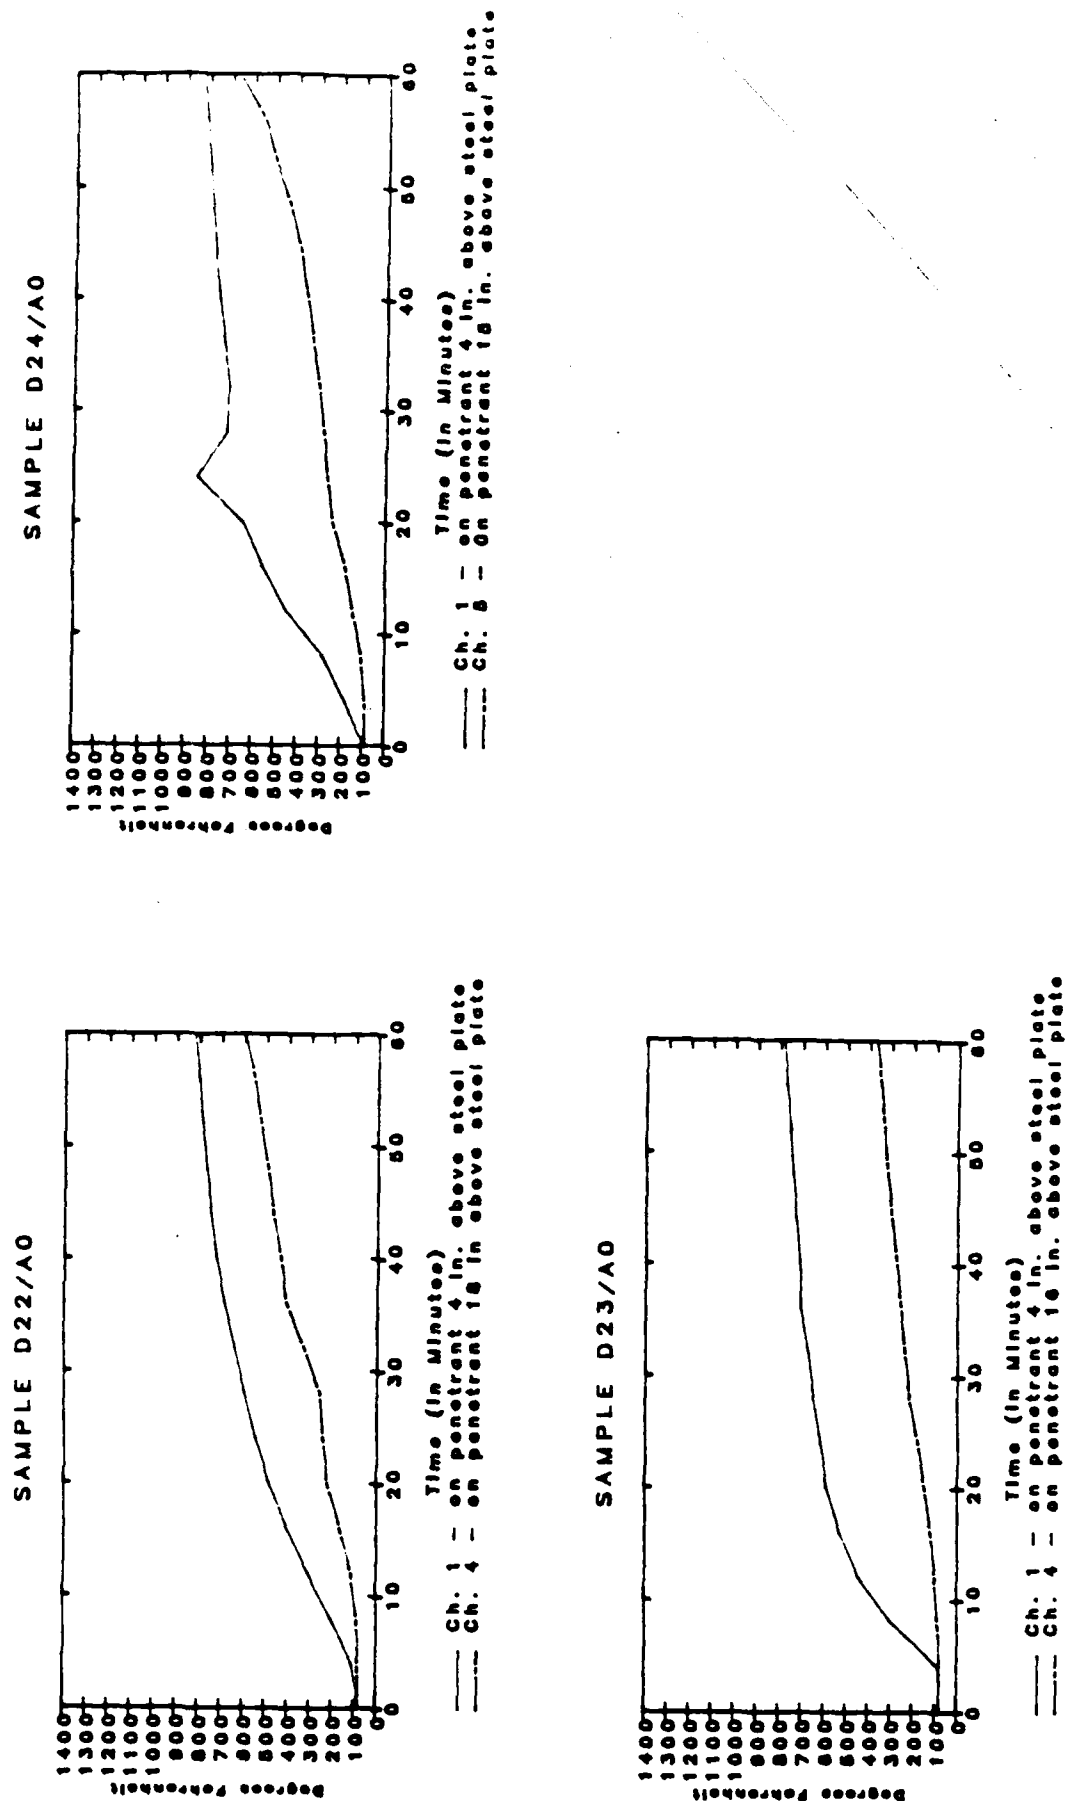
FIGURE 13. Temperatures on Electrical Cable Penetrations (D22/A-O, D23/A-O, D24/A-O) During Class A-O Test

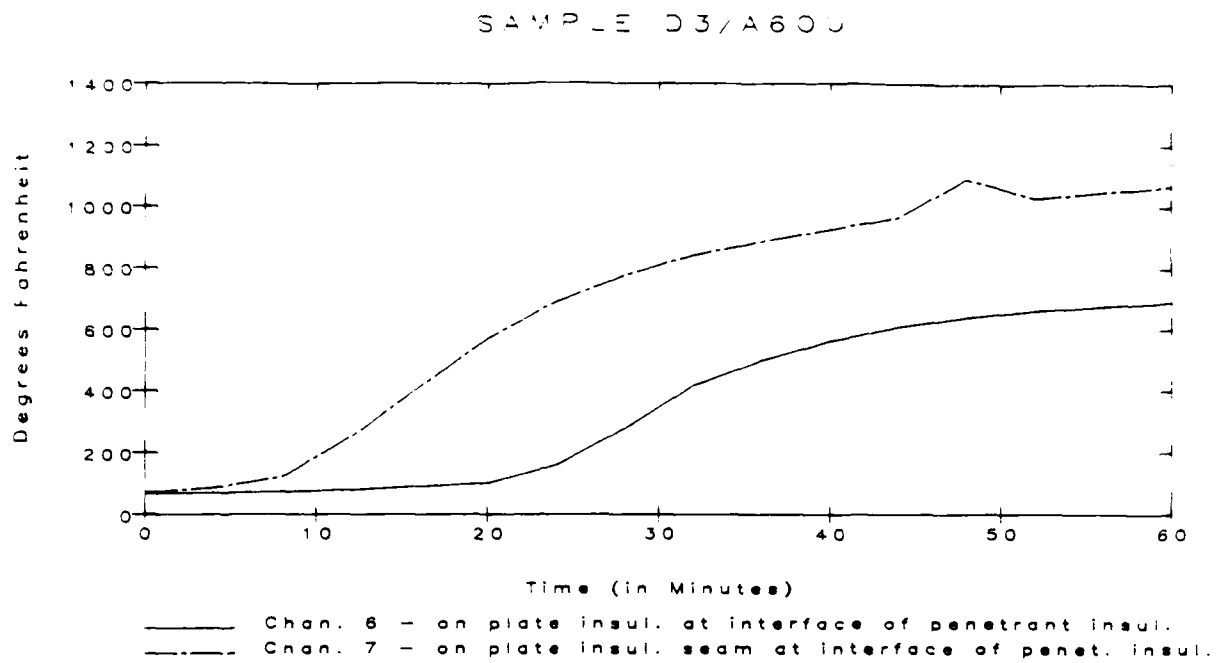
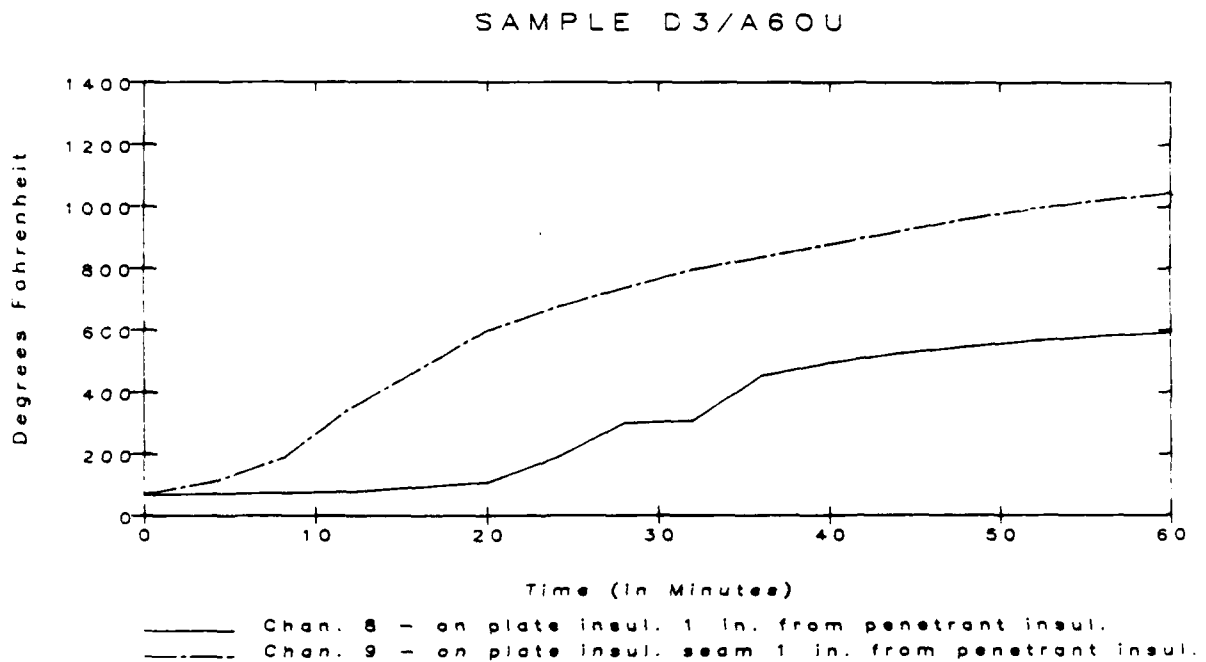
One steel penetration was insulated on the non-fire side and tested. It passed the fire exposure test and hose stream test, but failed to meet the temperature rise requirement. The temperature plots in Figure 14 show the heat transmission at different locations on top of the plate insulation. Two of the temperature plots shown in Figure 14 were recorded at the interface of the steel plate insulation and the penetrant insulation, while the other two temperature plots were recorded on the plate insulation 1-inch (2.5 cm) away from the penetrant insulation. This figure shows that the temperatures over the seams in the insulation at the two separate locations are over 350°F (194.4°C) hotter than temperatures recorded at similar locations but not over a seam. A seam occurred where two pieces of insulation were joined together. Each seam was tightly fitted, but small gaps could occur in the joints quite easily as the rough edges of the insulation were pushed together or as the samples were moved for testing.

FIGURE 14. Temperatures on Steel Penetration Failure (D3/A-60U) During Class A-60 Test

It is recommended that penetrations be insulated on the side of the deck or bulkhead which is most likely to be exposed to a fire, thus providing the most protection against heat transmission.

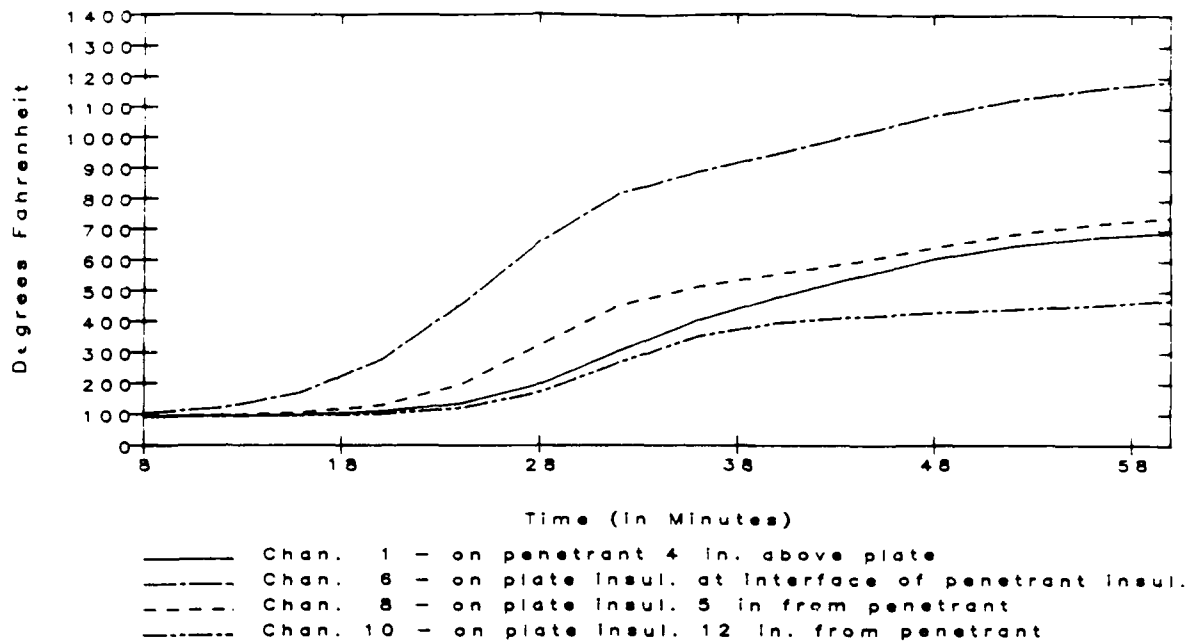
SAMPLE D4/A60U

Eight copper penetrations were insulated and tested. Two penetrations were insulated on the fire side and passed the requirements for a Class A-60 rating. Six penetrations were insulated on the non-fire side and failed the heat transmission test for a Class A-60 rating. Figures 15, 16, and 17 show temperatures above the acceptable temperature rise limits for the six penetrations which failed. These failure temperatures occurred on both the penetrant insulation and on the steel plate insulation for the six penetrations. Figure 18 shows the temperature plots for two copper penetrations which are identical in construction except that one sample is insulated on the fire side and the other sample is insulated on the non-fire side. Figure 19 shows the same arrangement for another pair of identical copper penetrations. In these two figures, the temperature plots show that the penetrations insulated on the non-fire side failed to meet the temperature rise requirement, while temperature plots at identical locations on the penetrations insulated on the fire side show these penetrations met this requirement. This points out the value of insulating the fire side to provide a greater degree of protection against temperature rise.

FIGURE 15. Temperatures on Copper Penetration Failures (D4/A-60U, D5/A-60U) During Class A-60 Test

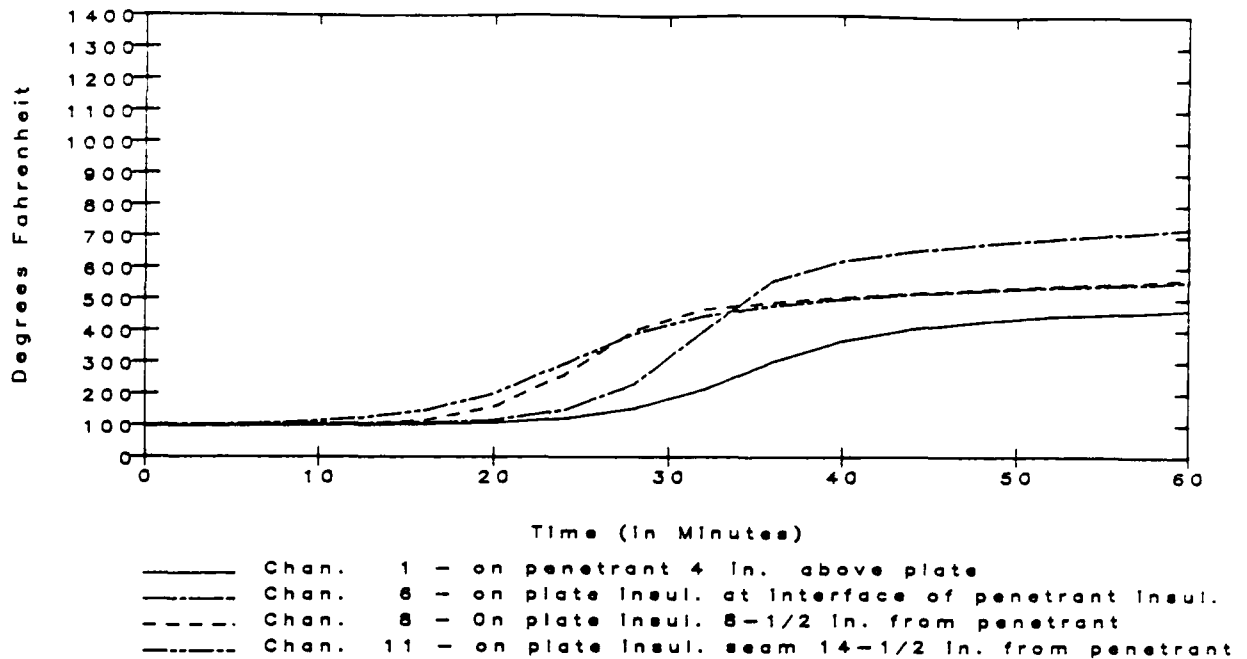
SAMPLE D6/A60U

FIGURE 16. Temperatures on Copper Penetration Failures (D6/A-60U, D9/A-60U) During Class A-60 Test

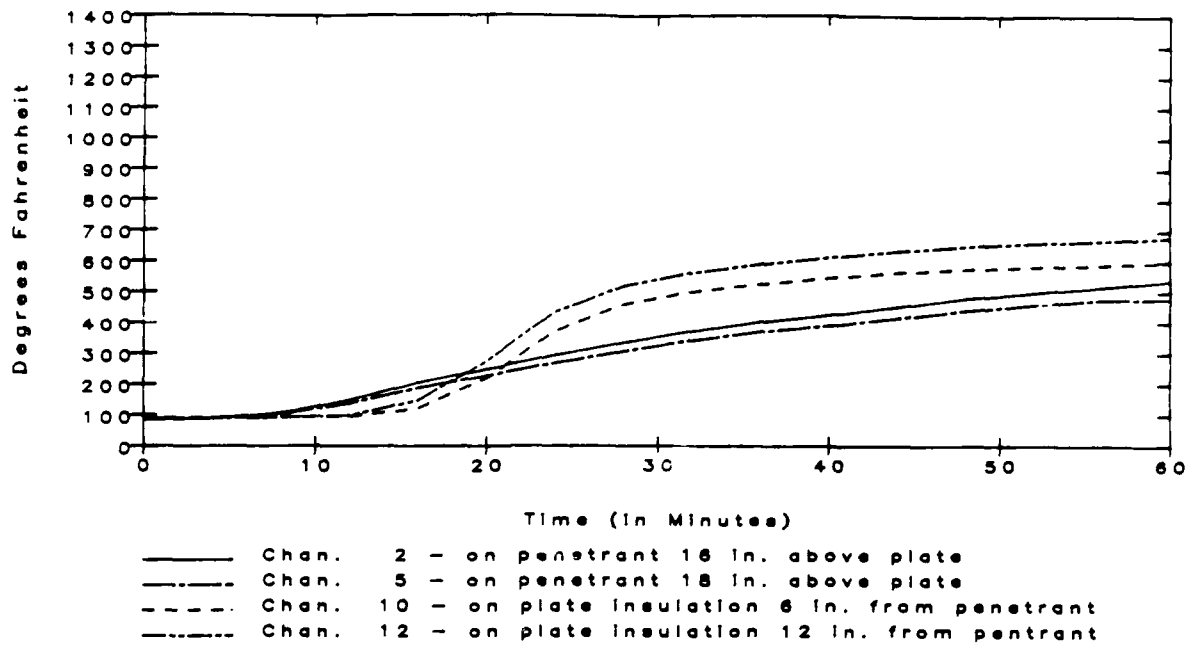
SAMPLE D10/A60U

FIGURE 17. Temperatures on Copper Penetration Failures (D10/A-60U, D11/A-60U) During Class A-60 Test

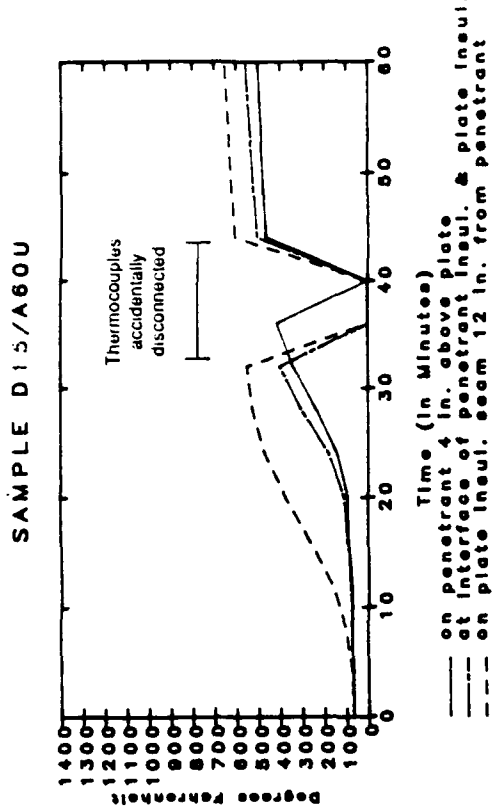
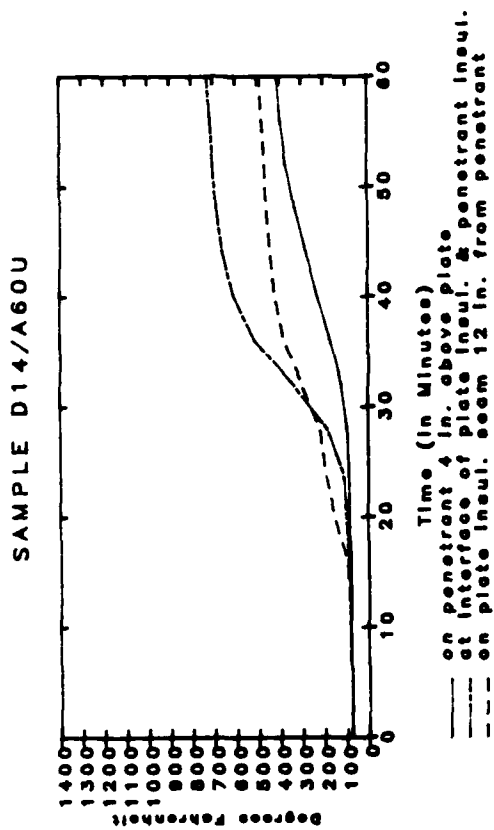
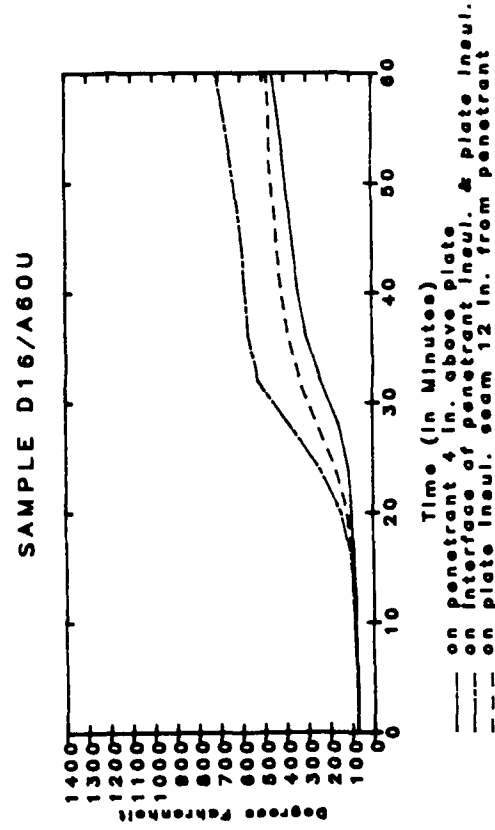
Four PVC penetrations were tested for a Class A-60 rating. Three of the penetrations were insulated on the non-fire side and failed the temperature rise requirement for a Class A-60 rating. The temperature plots in Figure 20 show that the temperature limits were exceeded for these three penetrations on both the penetrant insulation and the steel plate insulation. One penetration was insulated on the fire side and passed the test requirements for a Class A-60 rating. Figure 21 shows the temperature plots for two PVC penetrations which are identical in construction except that one sample is insulated on the fire side and the other sample is insulated on the non-fire side. The temperature plots show that the penetration insulated on the fire side passed the temperature requirement while the sample insulated on the non-fire side failed. Again, this indicates

FIGURE 20. Temperatures on PVC Penetration Failures (D14/A-60U, D15/A-60U, D16/A-60U) During Class A-60 Test

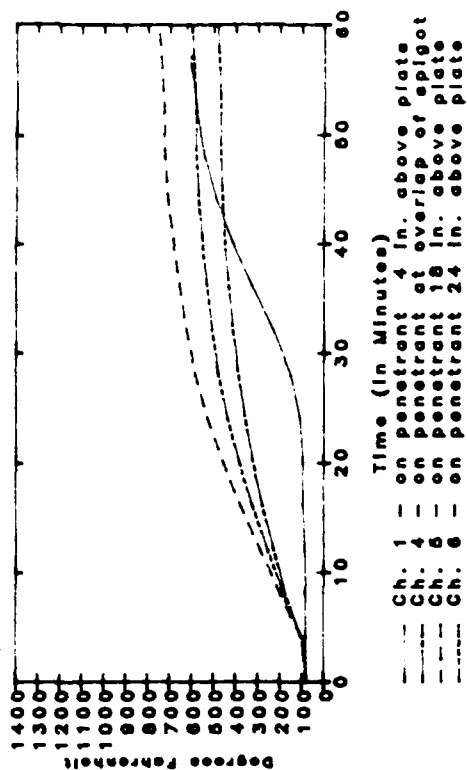
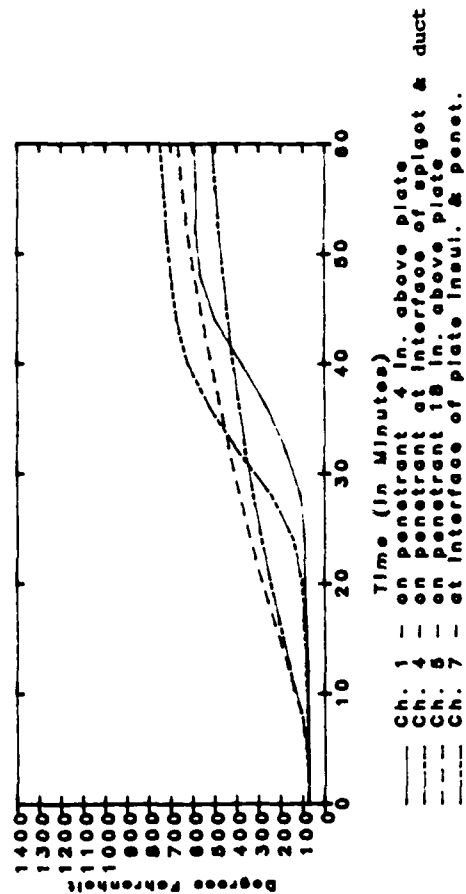
Six ventilation duct penetrations, two each of three different types, were tested. Three penetrations (one each of the three different types) were insulated on the non-fire side and the remaining three penetrations were insulated on the fire side. All six penetrations failed the temperature requirements for a Class A-60 rating. The temperature plots in Figure 22 show that the temperature rise for the three penetrations insulated on the non-fire side was above the acceptable limits for a Class A-60 rating. The temperature plots in Figure 23 show that the temperature rise for the three penetrations insulated on the fire side was above the acceptable limit for a Class A-60 rating. The test data in Appendix C for these six penetrations shows that the three penetrations insulated on the non-fire side failed the temperature requirements on both the penetrant insulation and deck plate insulation. Only two of the penetrations insulated on the fire side failed to meet the temperature requirements on the penetrant insulation and deck plate insulation whereas, the third penetration failed the temperature requirements on just the penetrant insulation.

FIGURE 22. Temperatures on Ventilation Duct Failures (D17/A-60U, D25/A-60U, D26/A-60U) During Class A-60 Test

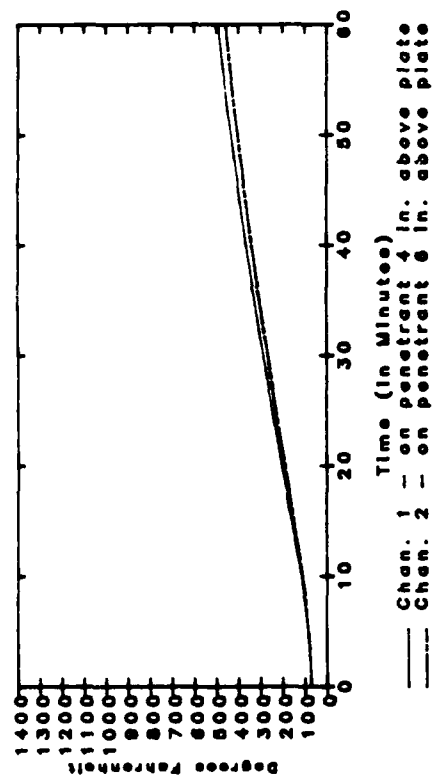
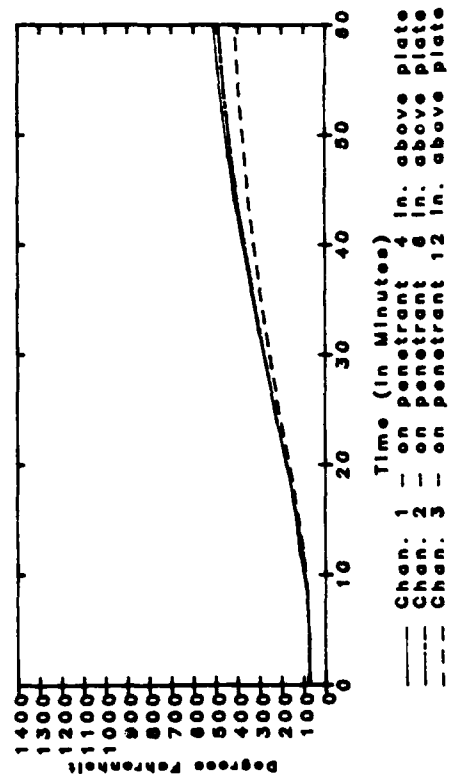
FIGURE 23. Temperatures on Ventilation Duct Failures (D17/A-60E, D25/A-60E, D26/A-60E) During Class A-60 Test

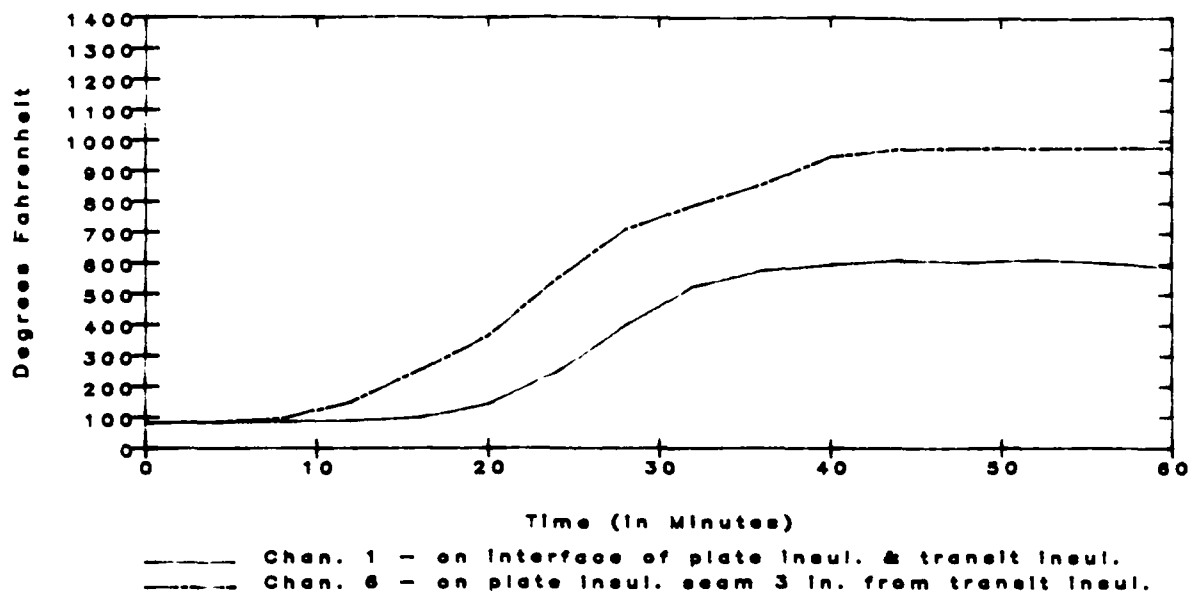
SAMPLE D19/A60U

Eleven electrical cable penetrations were tested. The brass terminal tube used in seven of these penetrations was missing its interior o-ring fitting. Fire retardant oakum was used in place of the missing o-rings. Five of the penetrations were insulated on the non-fire side, three were insulated on the exposed fire side, and three were only partially insulated on the test plate. The temperature plots in Figures 24 and 25 show that the temperature requirements for a Class A-60 rating were exceeded for the five penetrations insulated on the non-fire side. The three penetrants insulated on the fire side passed the temperature requirements for a Class A-60 rating, but two of the penetrants (D23/A-60E and D24/A60E) did fail the additional requirement of preventing the passage of smoke. The three penetrations partially insulated over either one side or both sides of the steel plate failed the temperature requirements for a Class A-60 rating. The penetrations represented in Figures 25 and 26 are identical in construction and differ only in the location of the insulation. It is interesting to note that the three penetrations in Figure 26 were insulated on the fire side and passed the temperature requirements for a Class A-60 rating, whereas the five penetrations in Figure 25 were insulated on the non-fire side and failed the temperature requirements for this rating. Figure 27 shows the temperature plots at three heights on cables in the three partially insulated penetrations. This figure shows that the penetration sample D19/A-60-3E & 3U, insulated on both sides of the steel plate, provided the lowest temperatures at a 6-inch (15.2 cm) height on the cables whereas the penetration sample D19/A-60-6U, insulated on the non-fire side, provided the highest temperatures at the 6-inch (15.2 cm) height on the cables.

FIGURE 24. Temperatures on Electrical Cable Failures (D19/A-60U, D21/A-60U) During Class A-60 Test

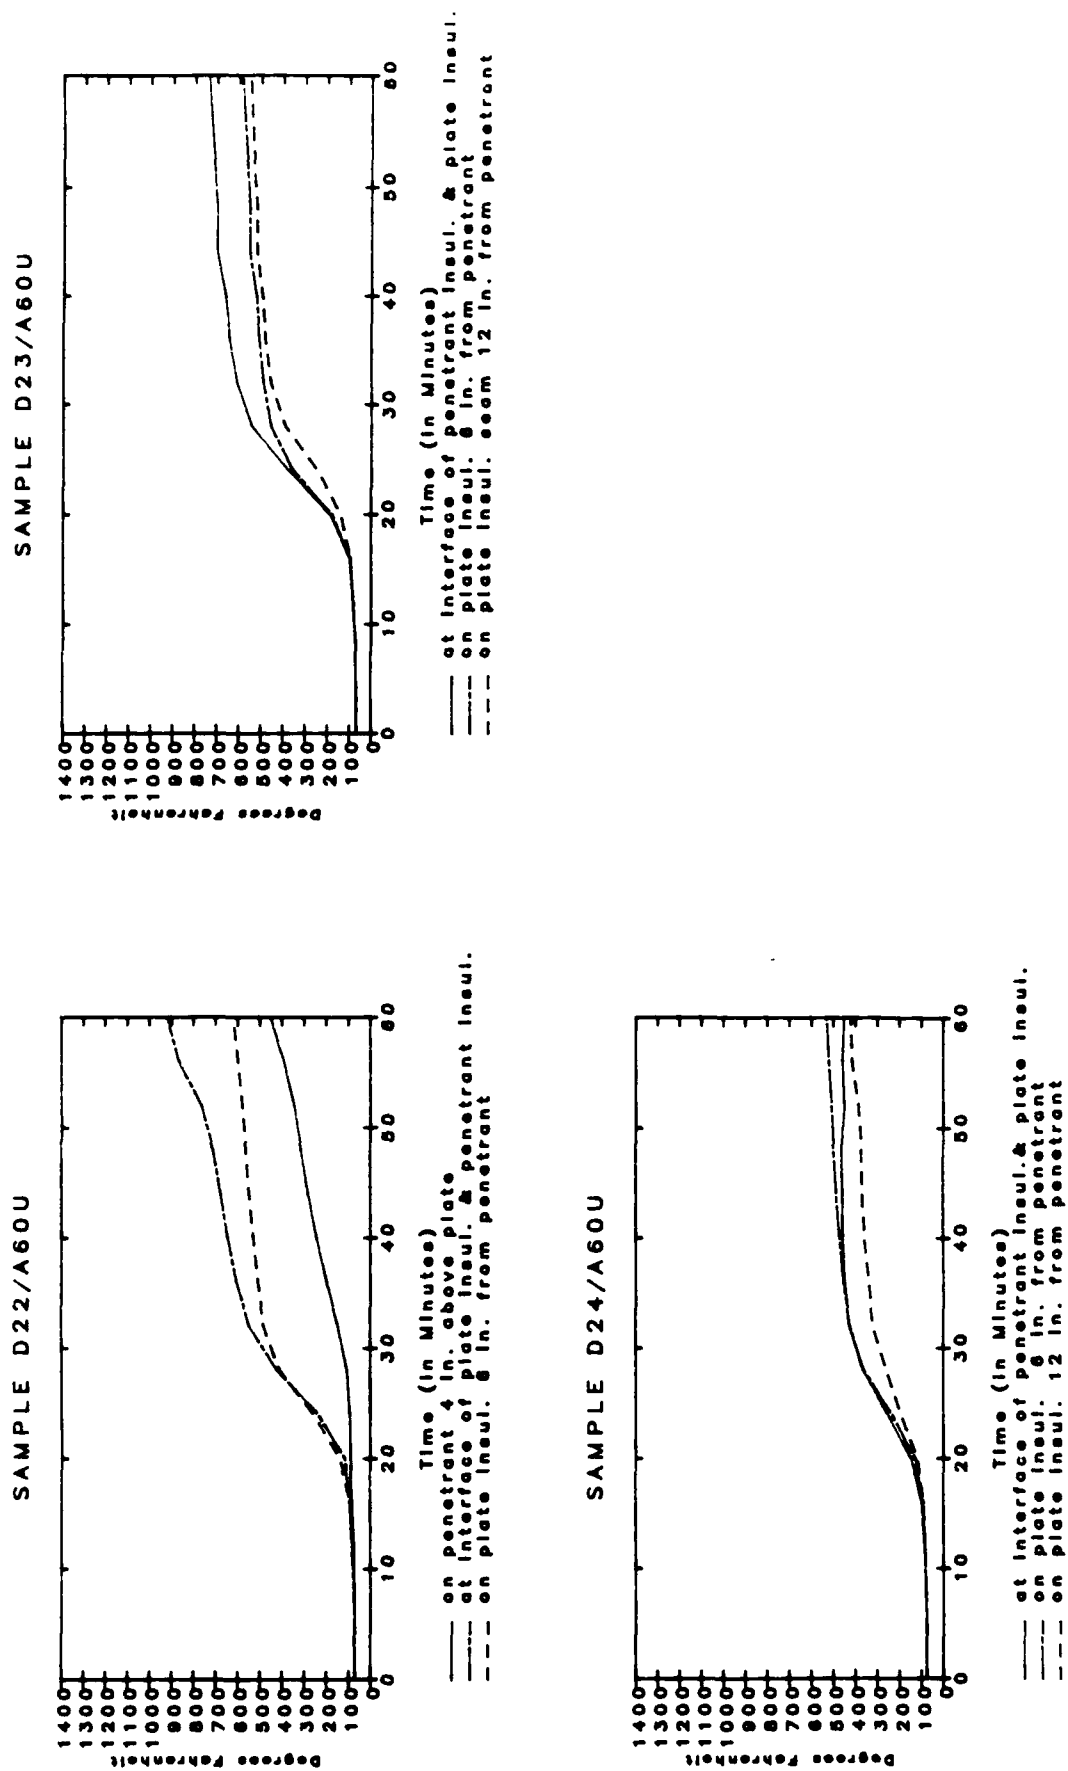
FIGURE 25. Temperatures on Electrical Cable Failures (D22/A-60U, D23/A-60U, D24/A-60U) During Class A-60 Test
